TECHNICAL SERVICE BULLETIN

Lack Of Heat Or Cooling From The Cabin Vents - Temperature Door Or Door Actuator Binding/Inoperative - DTC B1081:07

2236

Ford 2015-2019 F-150
2017-2019 F-Super Duty

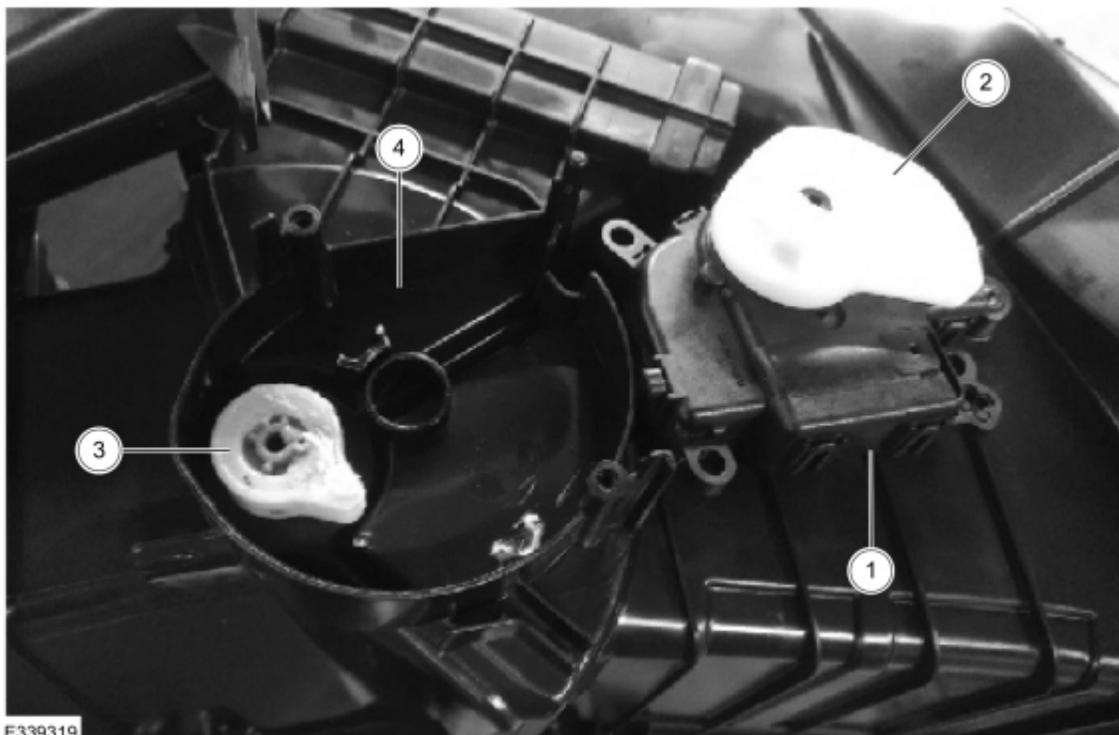
E339319

NOTE: Do not remove the cam follower from the climate control housing blend door. It is critical to be gentle when cleaning the cam follower as damaging the temperature blend door shaft will require replacement of the climate control housing. (Figure 1)

- Gently wipe the driver side temperature blend door actuator, cam, and cam follower attached to the climate control housing blend door to remove any debris and existing lubricant.

2. Replace the driver side temperature door actuator and cam. Refer to Workshop Manual (WSM), Section 412-00. Reapply fresh grease to the cam and cam follower pin using Motorcraft® HVAC Duct Component Grease.
3. Reassemble per WSM. Test the temperature blend door operation. Does the system operate properly?
 - (1). Yes - repair is complete.
 - (2). No - proceed to Procedure B.
